Technical Report CERC-95-3
March 1995

Periodic Inspection of Cleveland Harbor East Breakwater, Ohio

Report 1 Base Conditions

by Robert R. Bottin, Jr., WES

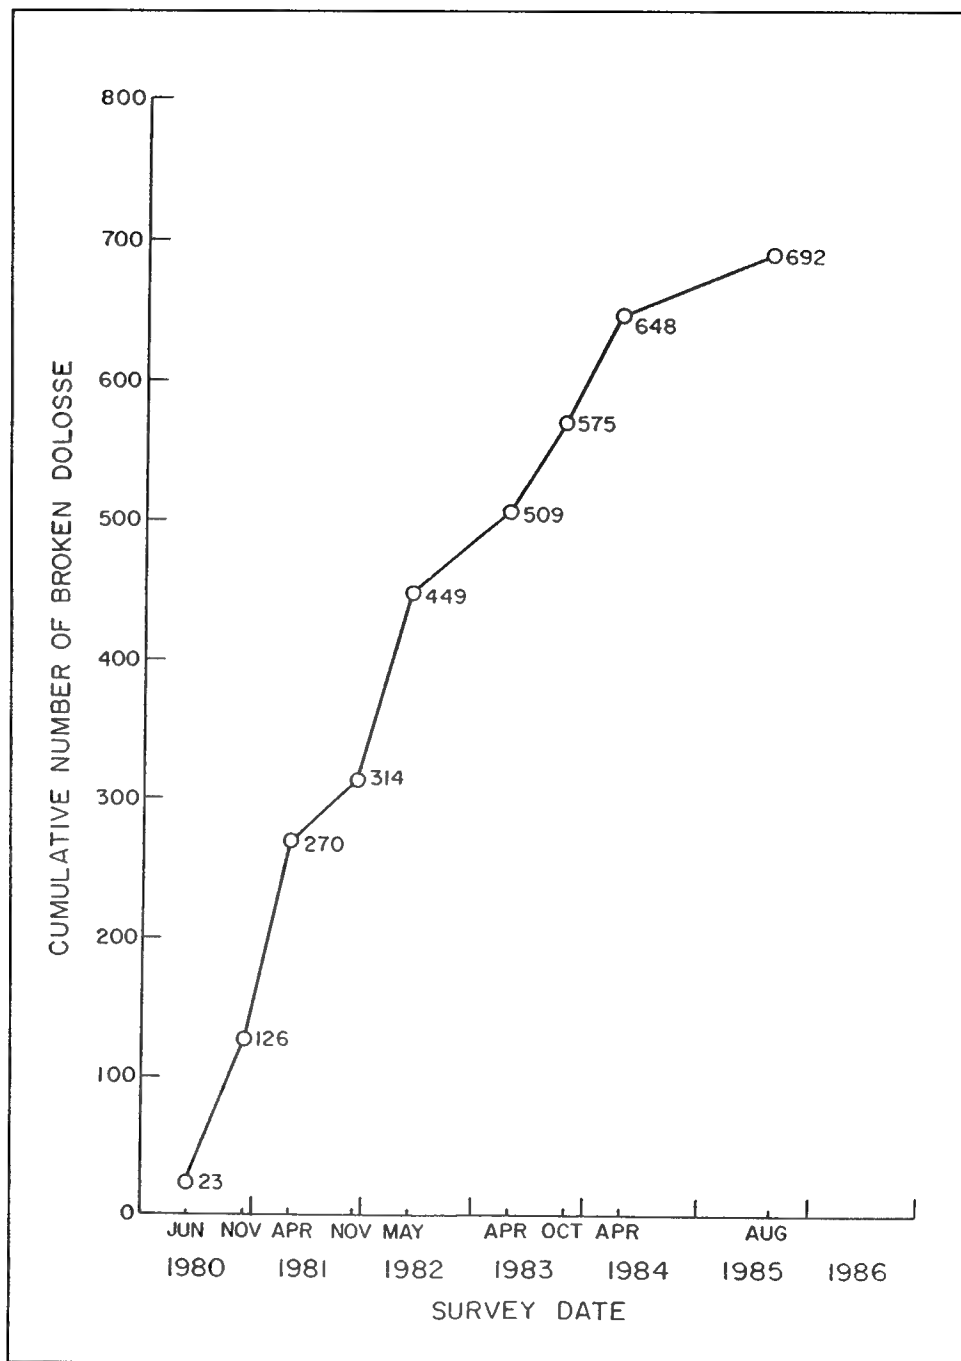
Evaluation of the broken dolos survey results from April 1980 to September 1985 indicated a total of 692 broken units above the waterline. The rate of new breakage appeared to have decreased slightly with time as shown by the cumulative number of broken units during the monitoring period (Figure 11). Approximately 30 percent of the dolosse were placed above the average annual mean lake level during construction. Therefore, about 8,972 dolosse of the total 29,741 were placed above the waterline within the primary wave impact zone. With 692 units broken, this yielded approximately an 8-percent breakage rate over the monitoring period ignoring below-water breakage.

Figure 11. Cumulative number of broken dolos during the monitoring period

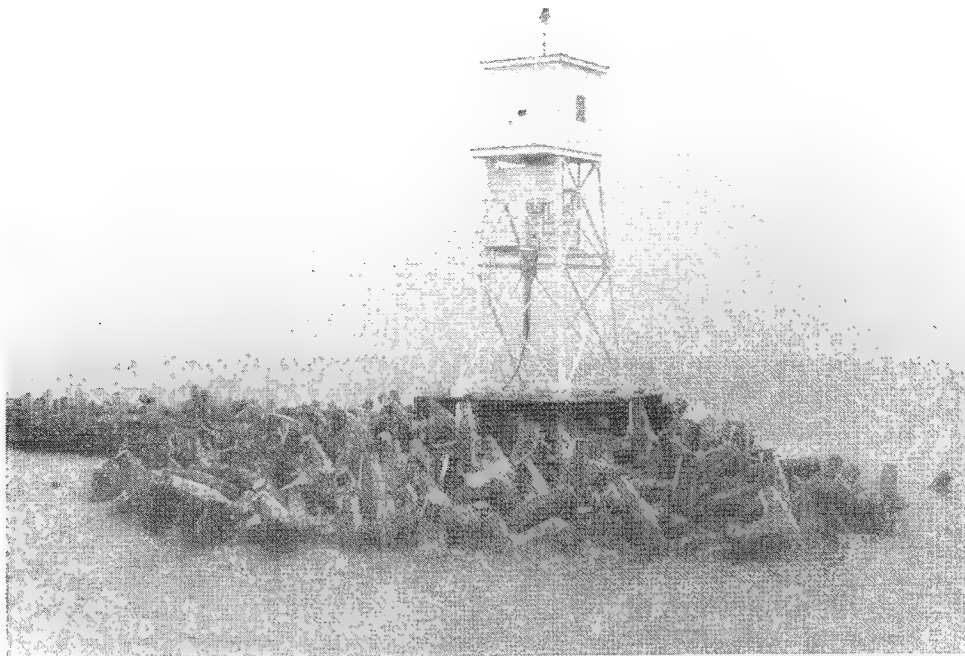
Figure 13. View of 4-ton dolos units placed around head of structure in May 1987

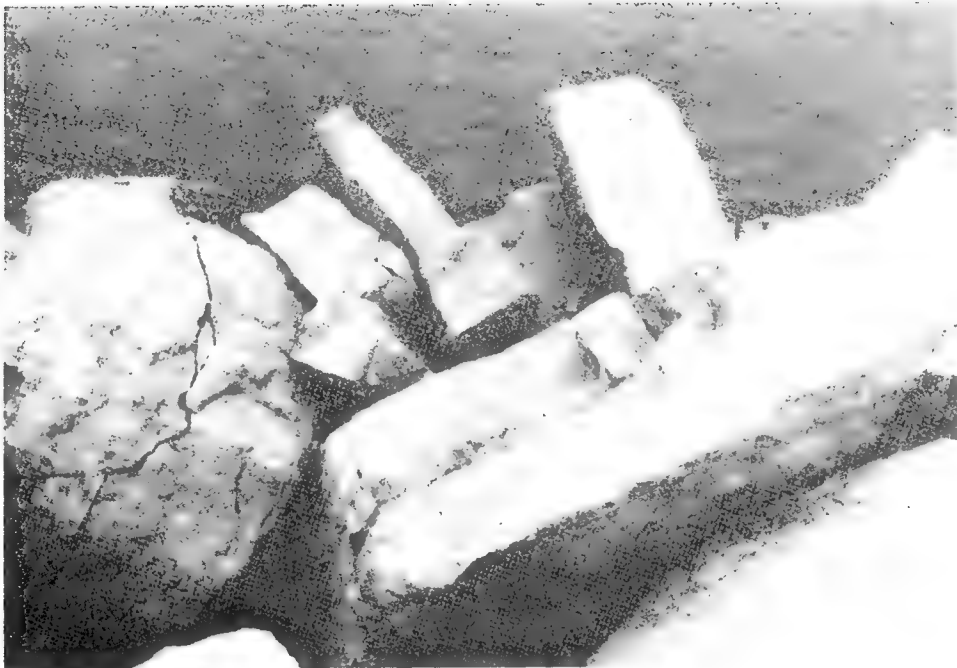
- d. Location of crack, as related to geology (Marcus 1991).
- e. The apparent mechanism for cracking. This is based on stone stress characteristics, man-influenced blast effects (Figure 15) or cracking by natural causes (Figure 16).

Figure 15. Typical man-influenced blast crack damage observed on all study reaches

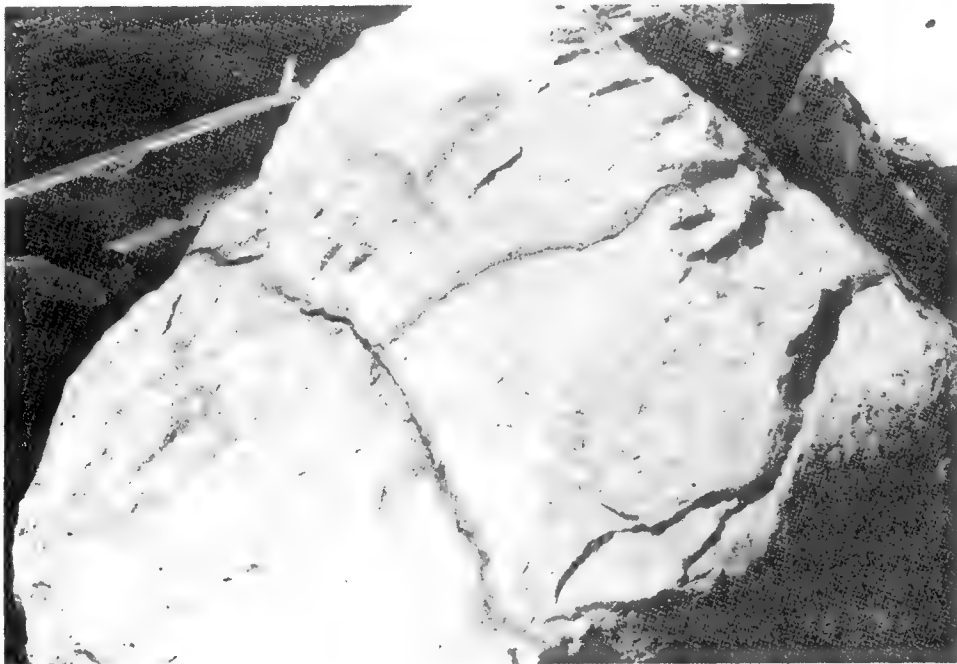
Figure 16. Typical natural mirror image fracturing observed on all study reaches

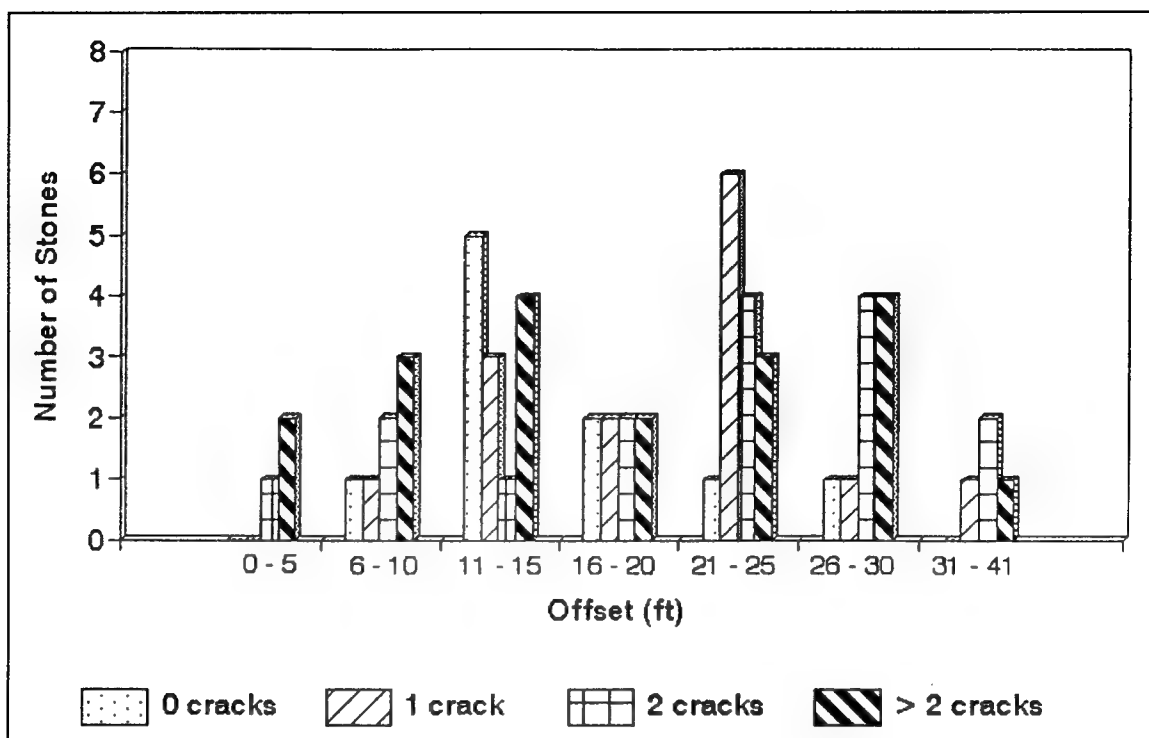
Study Reach 1 (sta 197+65-198+65) has been monitored annually throughout the project and is the best documented of the three study reaches. The Reach 1 evaluations reveal that of 59 stone armor units monitored between 1989 and 1992, random cracking is occurring across the entire profile of the breakwater reach (Figure 17). However, the relative frequency of the crack damage-type is largely skewed to the lakeside of the structure (Figure 18). Over the four years of monitoring, the worst damage classification, type "D," is occurring at or near the waterline. The number of significant cracks has increased with time on both damaged and undamaged stones. Of 12 good stones documented in 1989, two became significantly damaged by 1992; one cracking in each of the 6th and 7th years of exposure. The degree of damage change was highest between 1989 and 1990, likely due to increased storm frequency and duration compared with later years. The apparent mechanism for cracking is about half blast related and half natural. Of 93 cracks documented in study Reach 1, 49 were recorded as blast related (53 percent), and 44 cracks (47 percent) were apparently caused by natural consequences such as freeze-thaw, wet-dry, or other weathering factors. At the end of monitoring in 1992, 83 percent of the stones on study Reach 1 was documented as being cracked.

Figure 17. Cracked stone distribution along study Reach 1

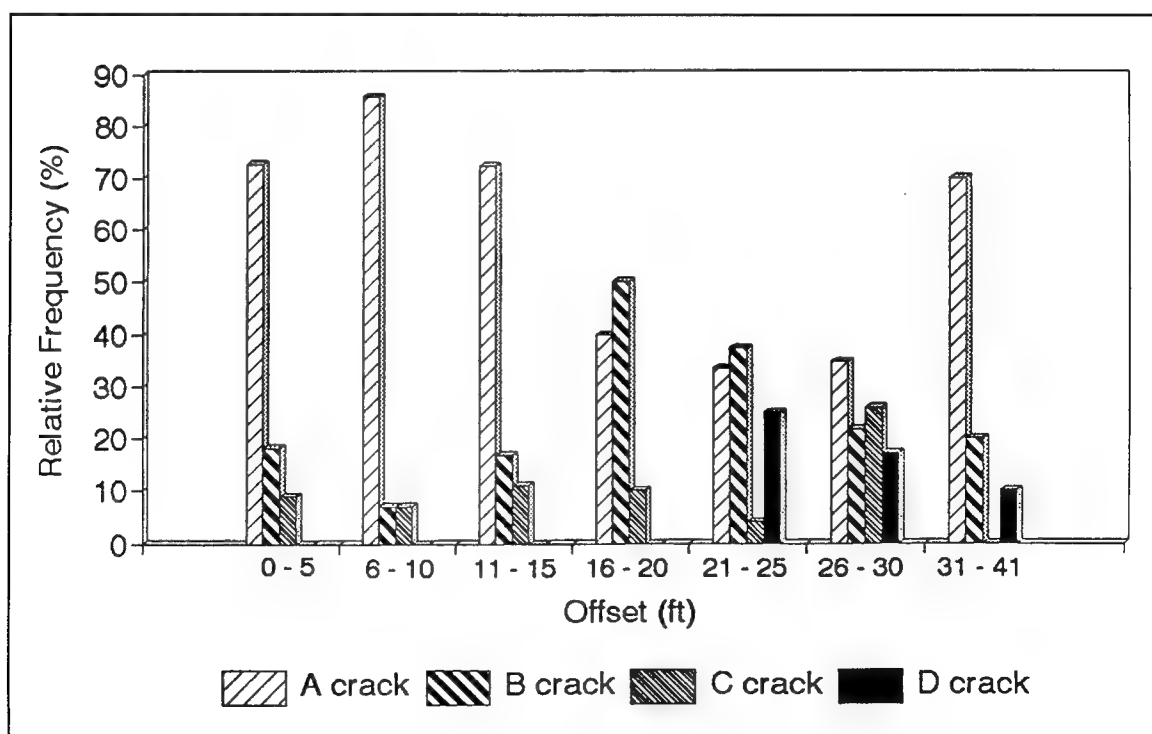
Figure 18. Relative frequency crack damage-type distribution versus offset distance from baseline

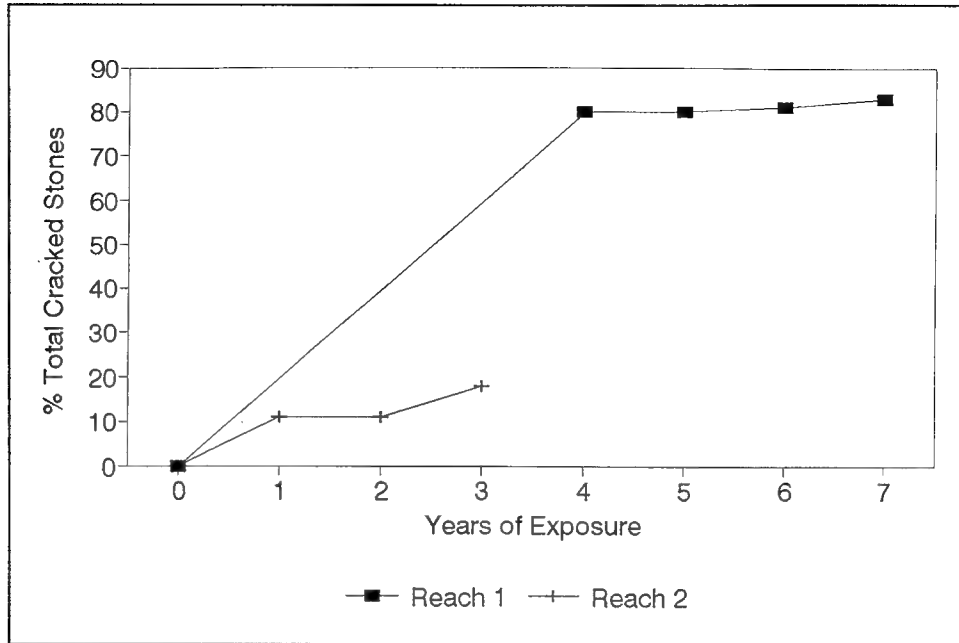
In 1990 (one year after construction), the enhanced QC/QA effort of study Reach 2 (sta 107+50-108+50) was initially deemed successful because less than 1 percent of the stones monitored revealed crack damage. At the quarry about one-half of the total stone stockpile had been rejected due to blast damage. This correlates closely with the 50 percent apparent blast crack damage recorded in study Reach 1. Evaluations two years after placement revealed 11 percent crack damaged stone on this study section and along additional portions of the rehabilitation. Similar to study Reach 1, cracking was observed randomly occurring throughout the structure. A small number of developing blast cracks were found and notes from the enhanced QC/QA program reveal that these damaged stones were often marginally passed. Three years of documentation on study Reach 2 indicated that the enhanced QC/QA operation has significantly reduced the amount of blast damaged stone placed on the structure; however, natural cracking is still occurring. Study Reach 2 had a significantly lower cracking rate after three years of exposure (18 percent) as compared with the 83 percent cracked stone damage on study Reach 1 after four years. In addition, only 10 percent of the cracked stones on study Reach 2 have multiple cracks as opposed to about 50 percent on study Reach 1. A comparison of the percentage of cracked stones versus years of exposure for study Reaches 1 and 2 is shown in Figure 19.

Figure 19. Cracked stones for study Reach 1 versus study Reach 2

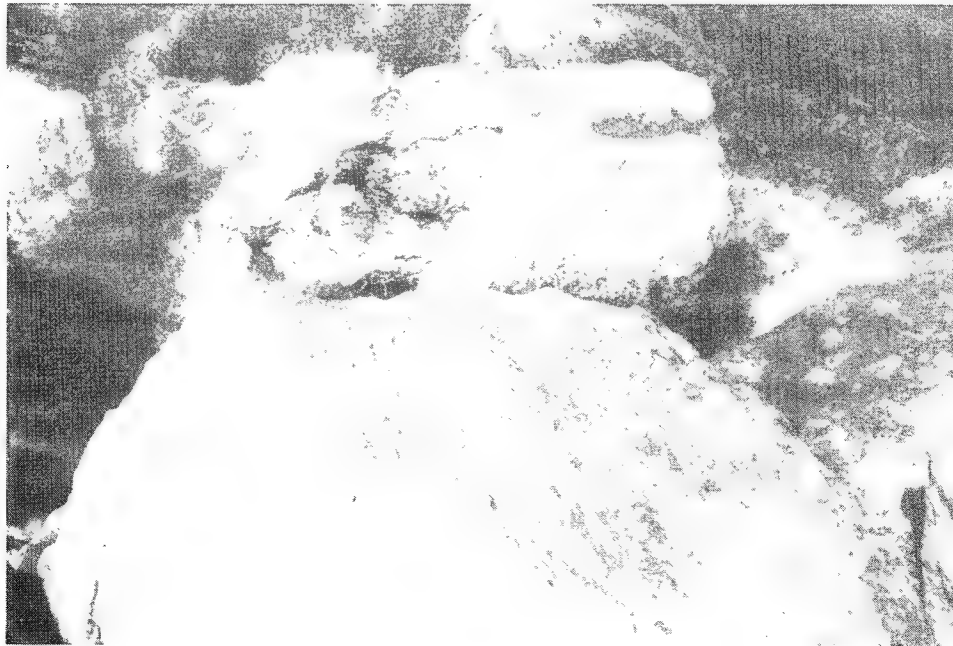
completed in 1992, and the standard Corps QC/QA practice was used. After the first year of exposure, 3 of 54 stones monitored (6 percent) had developed significant cracks. Two of these 3 stones had blast fractured cracks (Figure 20). Documentation of the 54 individual stones was conducted with videotape this season instead of 35-mm photography due to budget constraints.

Figure 20. Blast-fractured stone of study Reach 3 after one exposure season

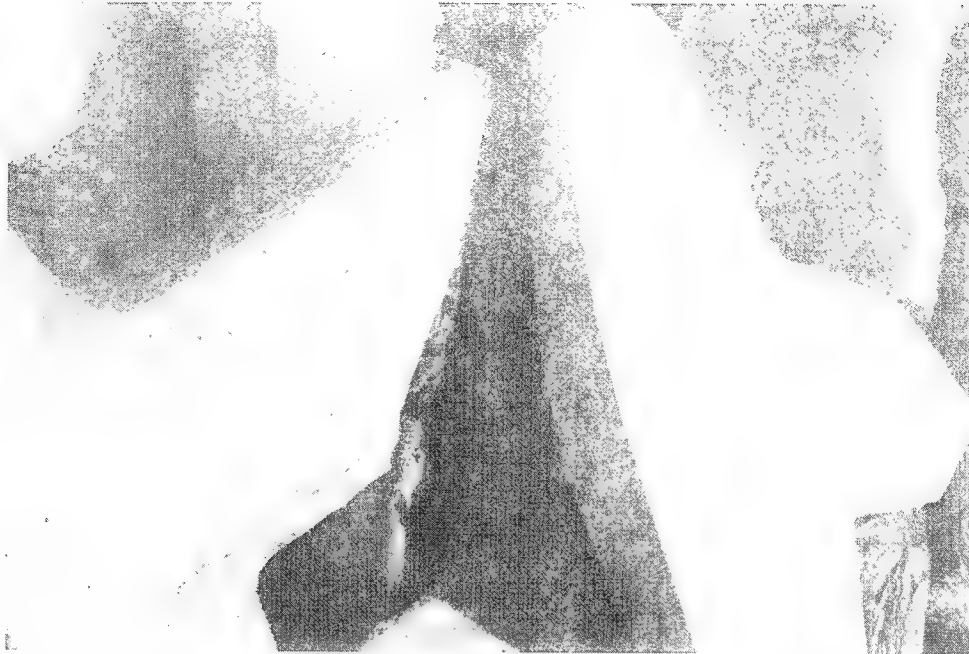
a. Angled mid-shank break

Figure 21. Dolosse with straight and angled mid-shank breaks

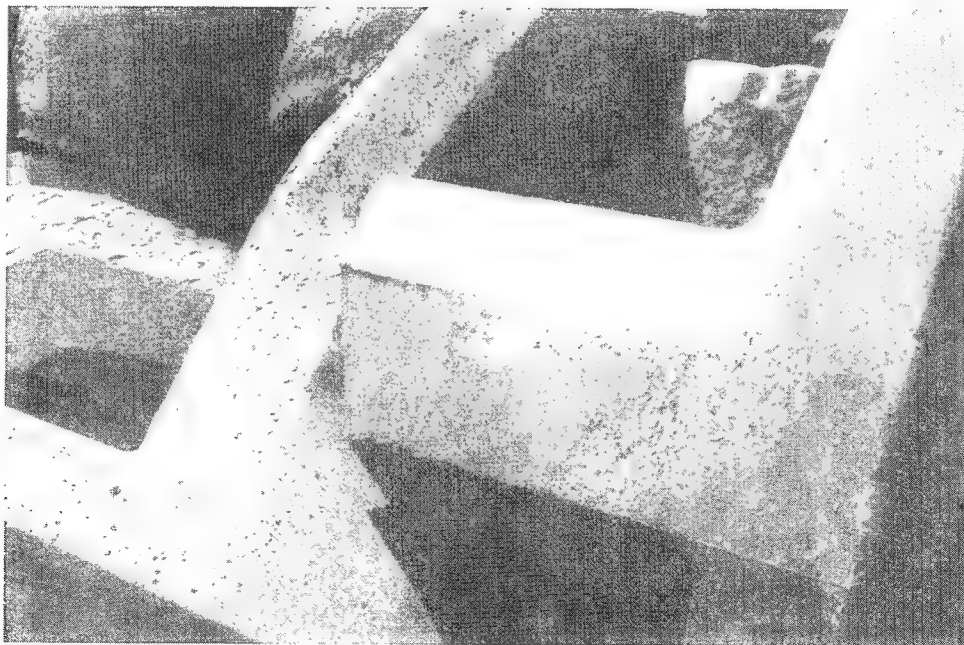
b. Straight mid-shank break

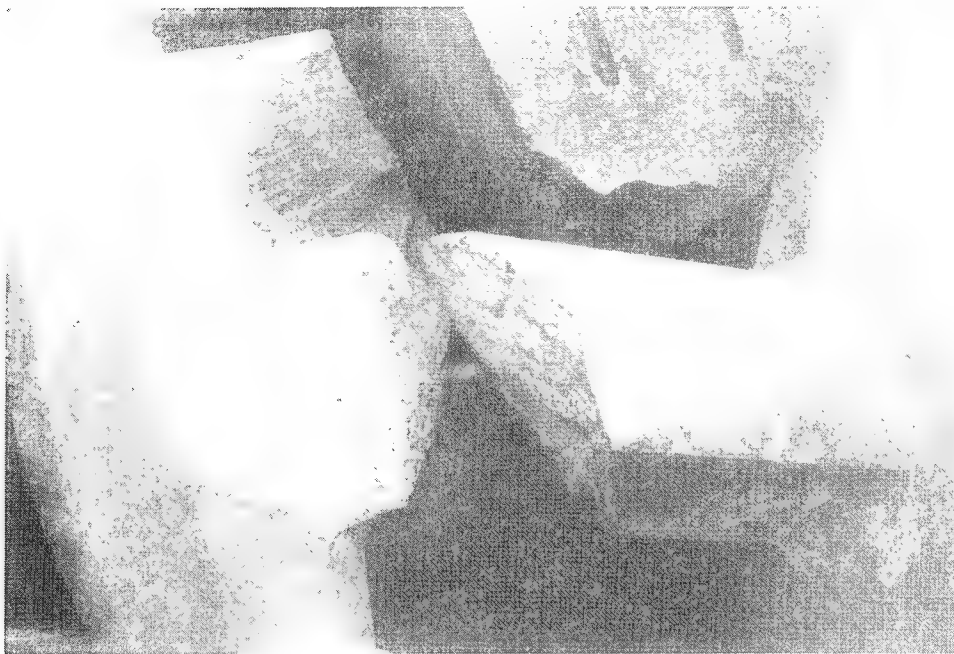
a. Angled shank-fluke break

Figure 22. Dolosse with straight and angled shank-fluke breaks

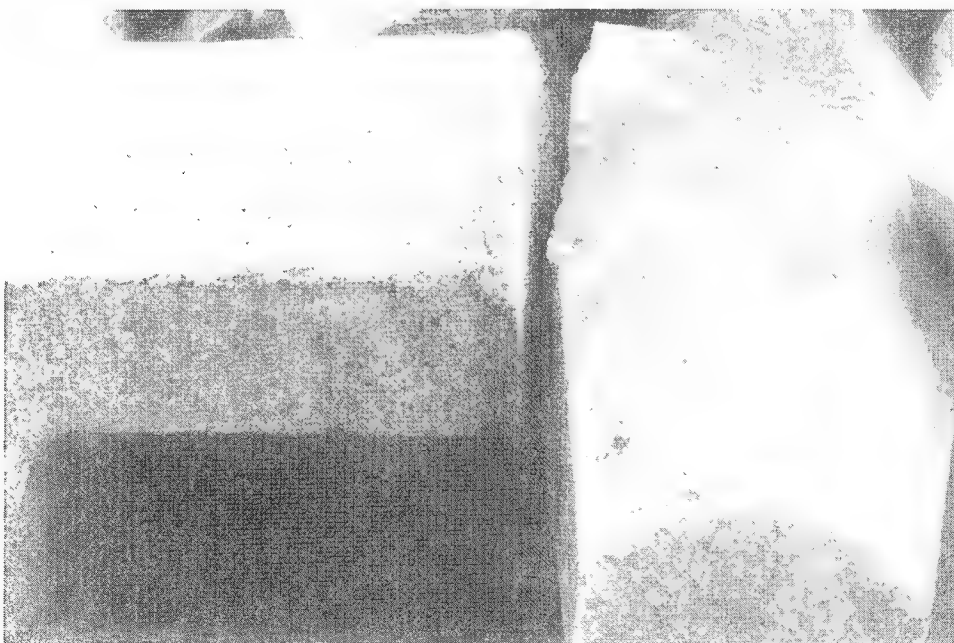
b. Straight shank-fluke break

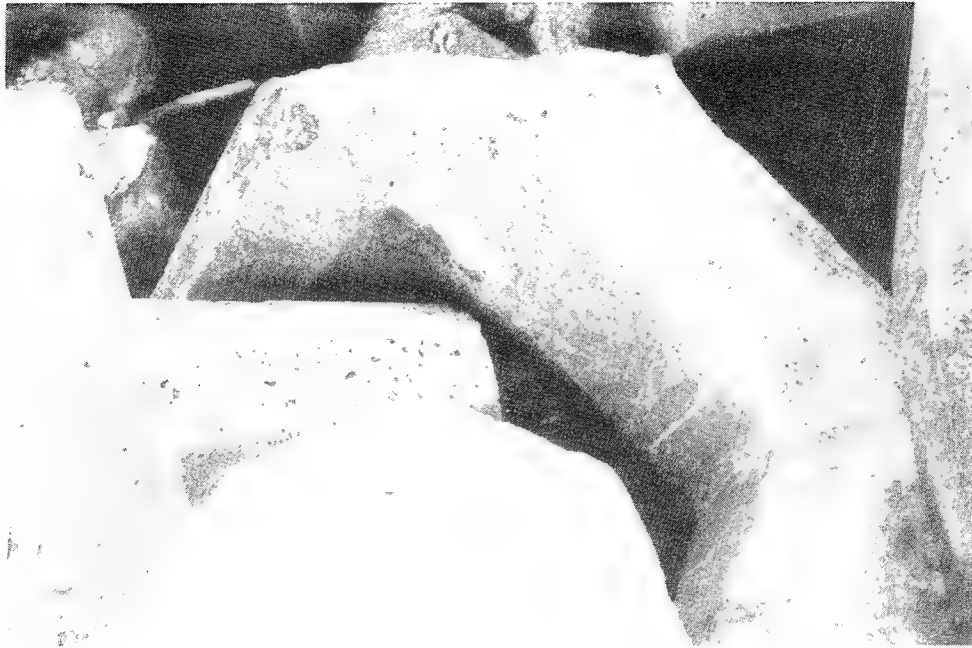
a. Angled fluke-shank break

Figure 23. Dolosse with straight and angled fluke-shank breaks

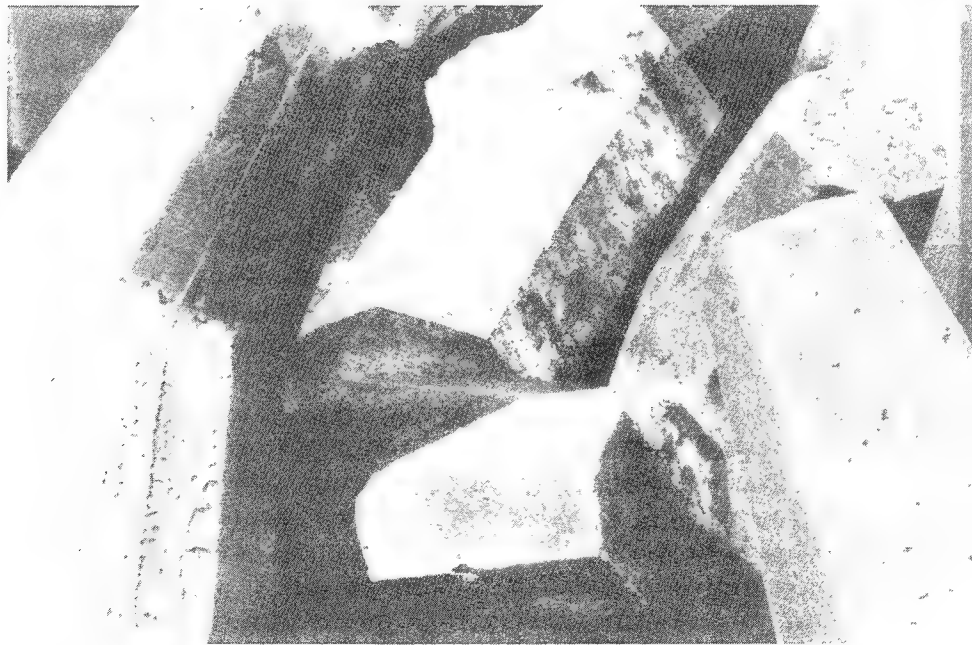
b. Straight fluke-shank break

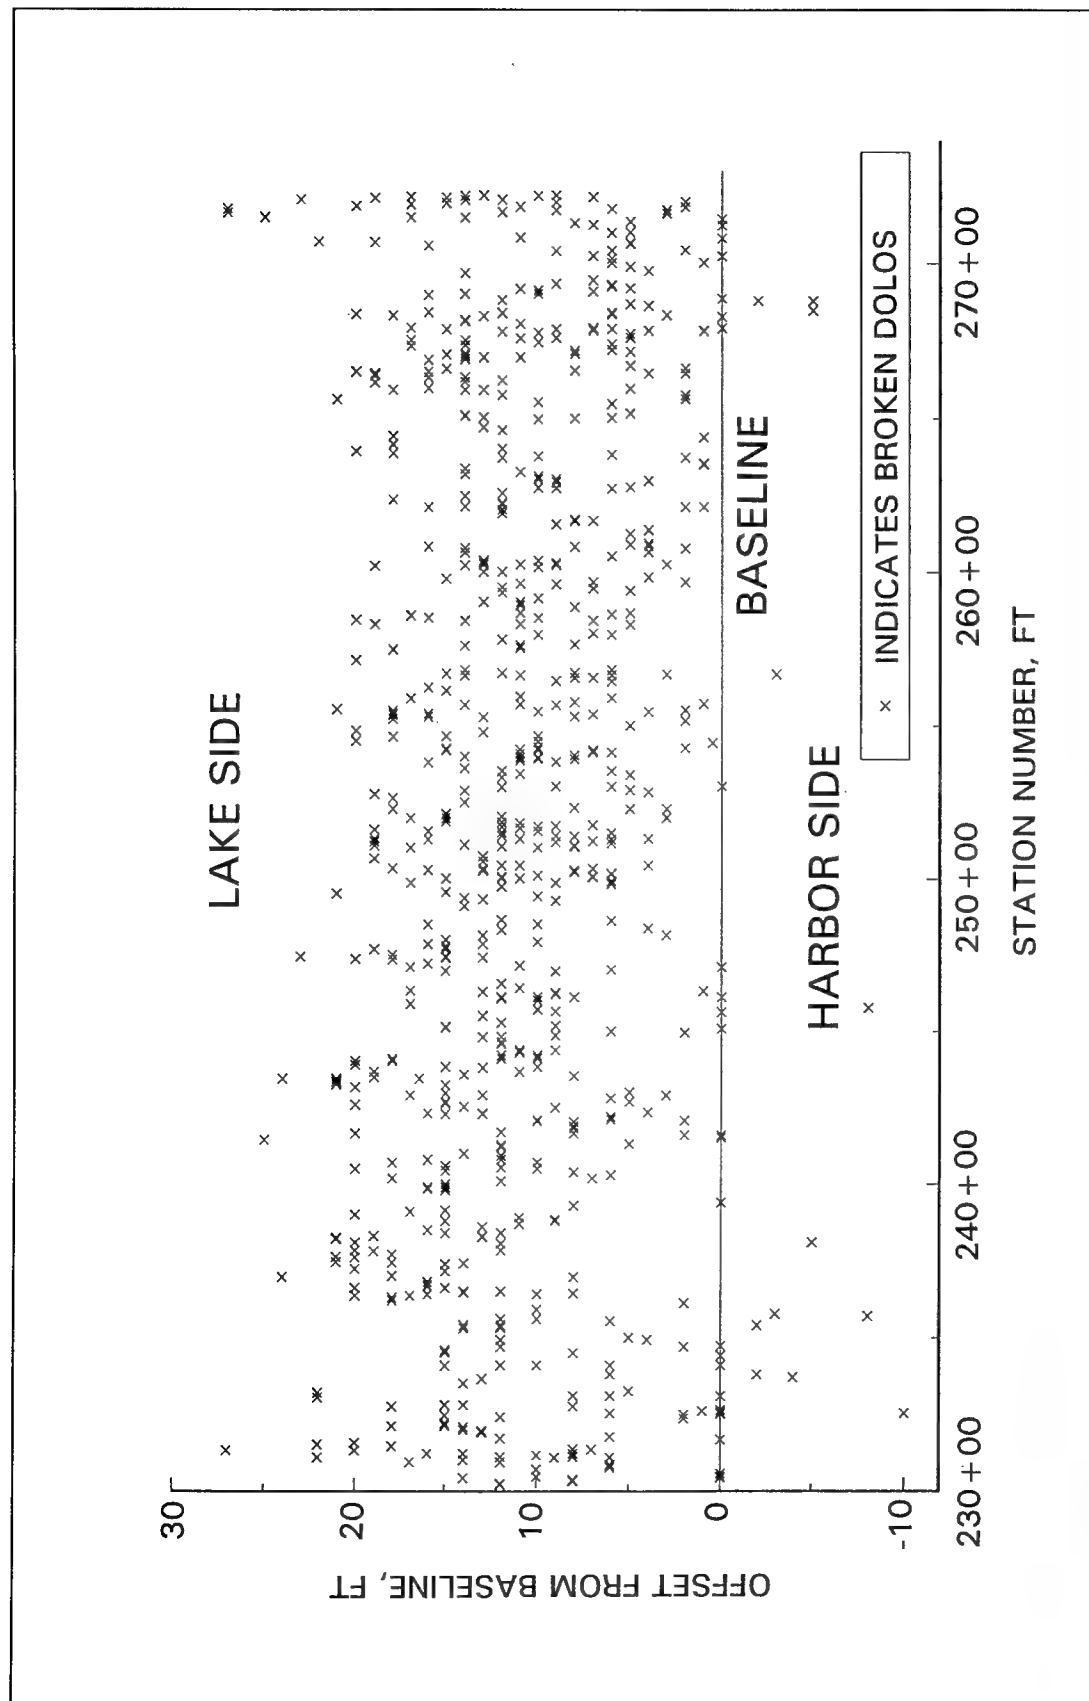
Figure 25. Distribution of broken dolos armor units along breakwater trunk relative to station number

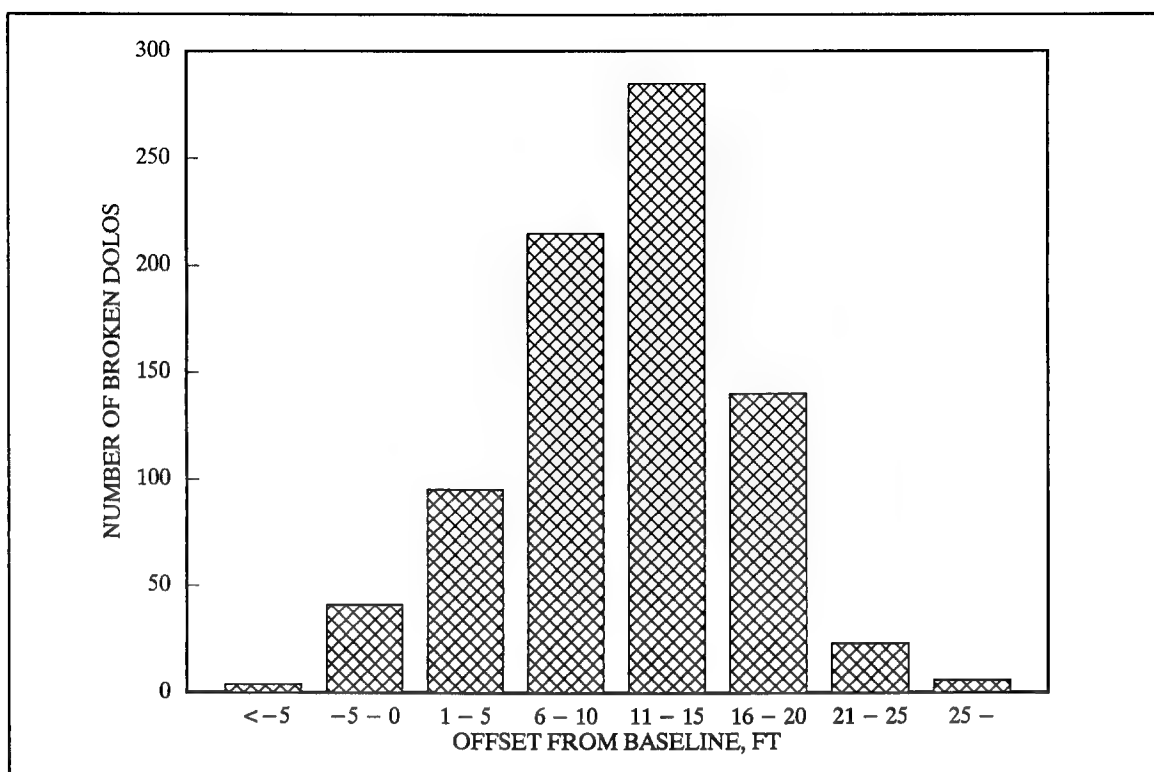
Figure 26. Distribution of broken dolos armor units relative to distance from baseline
